# Manhole Inspection Summary

Manhole # S15EE1026MH

**Location** Address: **2450 SHIRLEY AVE**

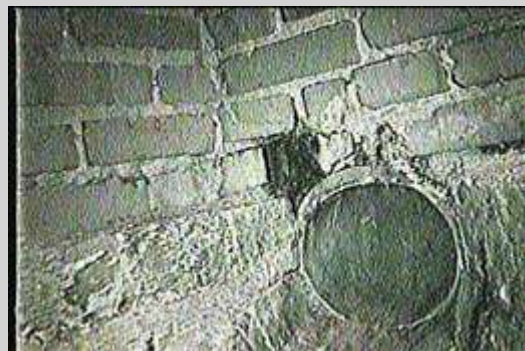
### Drop In @ 5 O'Clock

Infiltration: **Evidence** Pipe Seal Cond: **Cracked**

Drop: **Outside Direct**

Drop Condition: **Open**
